Task Order 2 Enhanced Preliminary Assessment

FORT DOUGLAS
SALT LAKE CITY, UTAH

December 1989

USATHAMA Task Order 2
ENHANCED PRELIMINARY ASSESSMENT REPORT

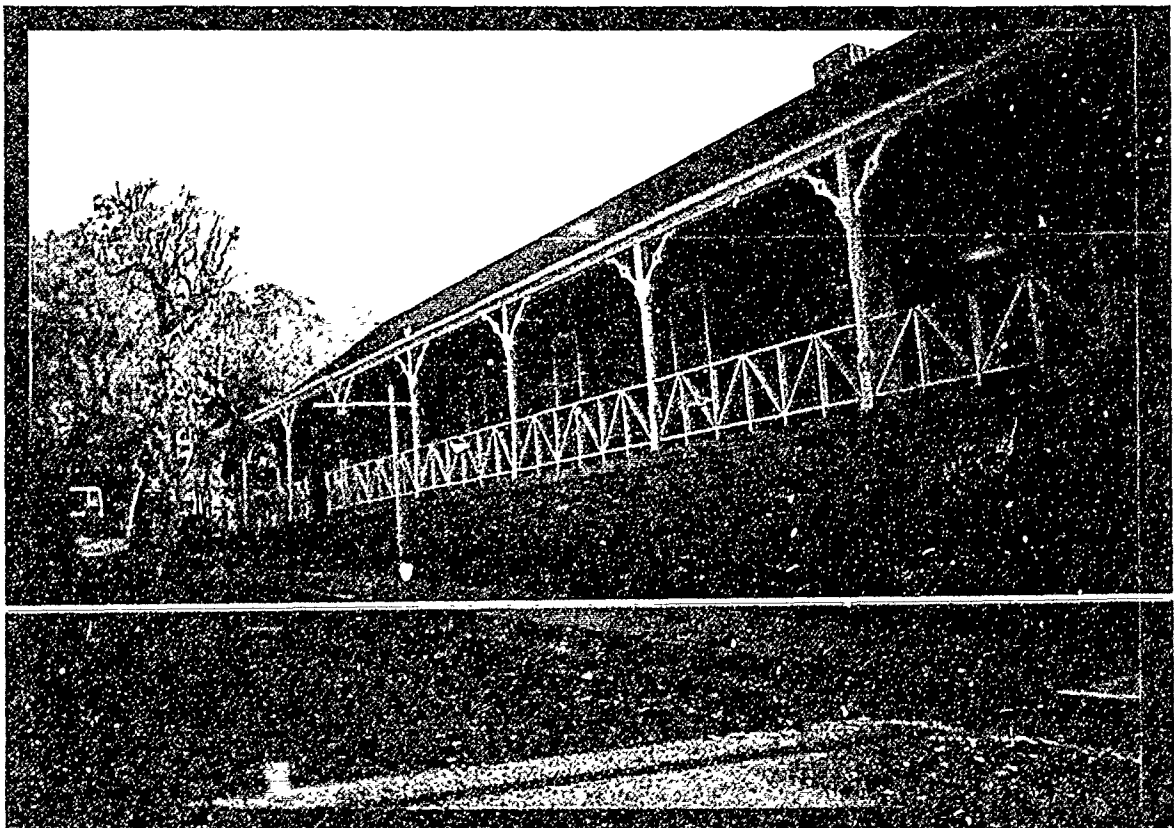
2. FORT DOUGLAS MUSEUM

The FD Military Museum (photo 2) houses exhibits that feature the history of the founding of FD, the history of the Army, Navy, Air Force, Marine Corps, and Coast Guard in Utah, and the history of the early Mormon military organizations. Asbestos insulation is present on the hot water pipes in the museum [T-7].

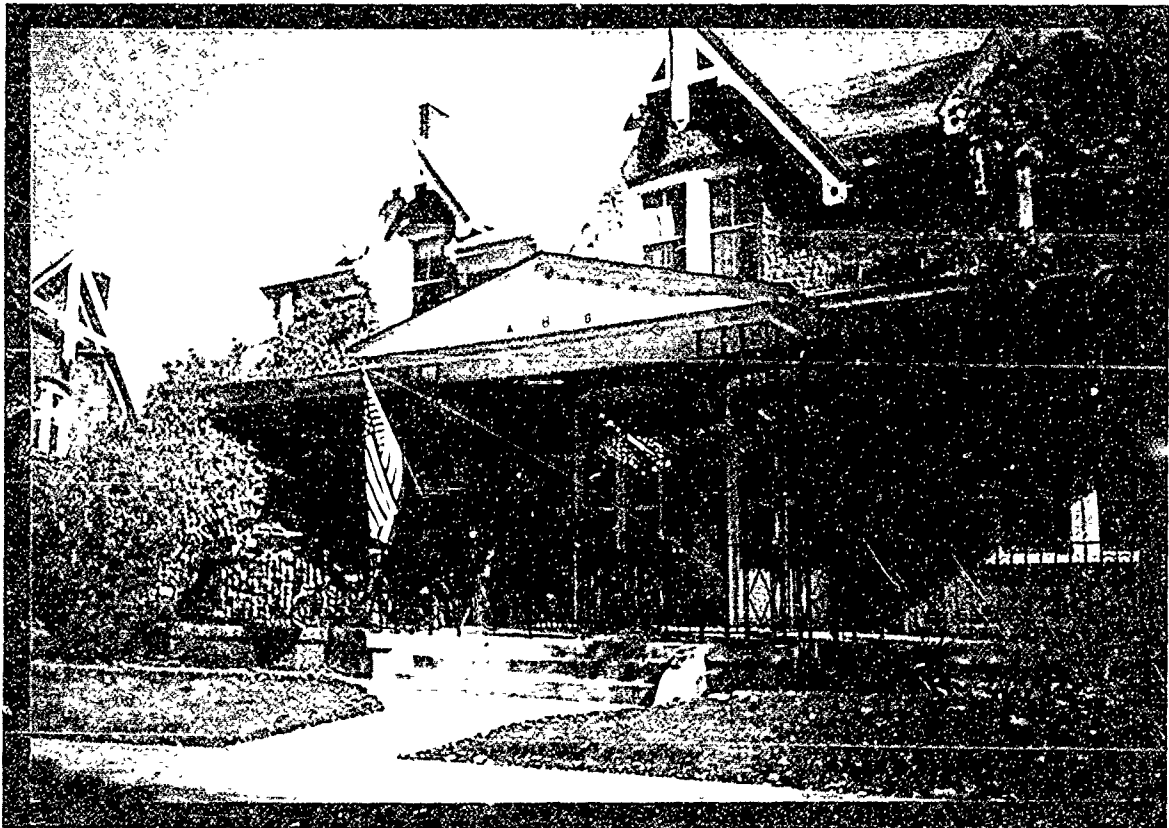
5. GENERAL CONDITIONS OUTSIDE OF FAMILY HOUSING UNITS:
BUILDING 8A AND 8B

Of the 39 residential buildings, four buildings were accessible for survey purposes during the site visit. In addition, the NCO Club, Officers Club, bath house, water treatment building, swimming pool, and the cemetery were surveyed. The residential buildings represent four different models of homes, and photos 5 through 8 show their general exterior condition. These buildings are:

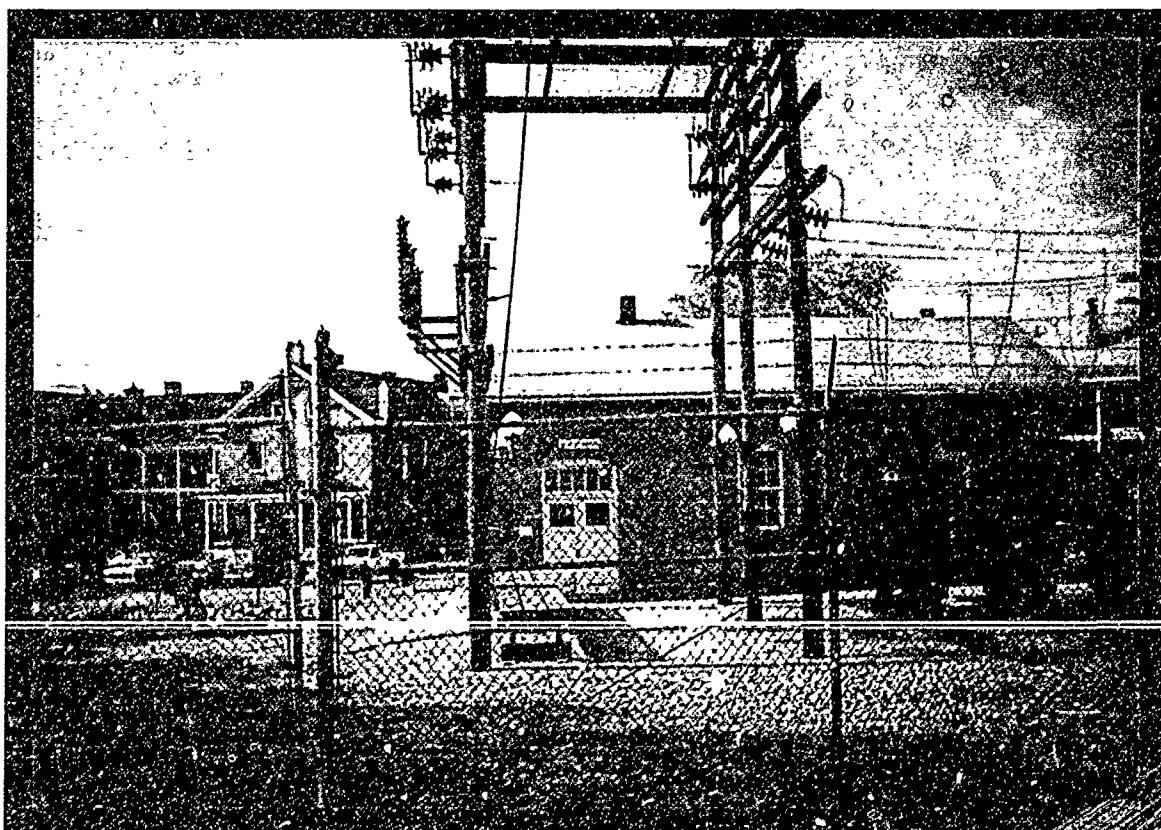
10. FD ESO IN THE AREA TO BE RETAINED:
SUBSTATION WITH TRANSFORMER STORAGE

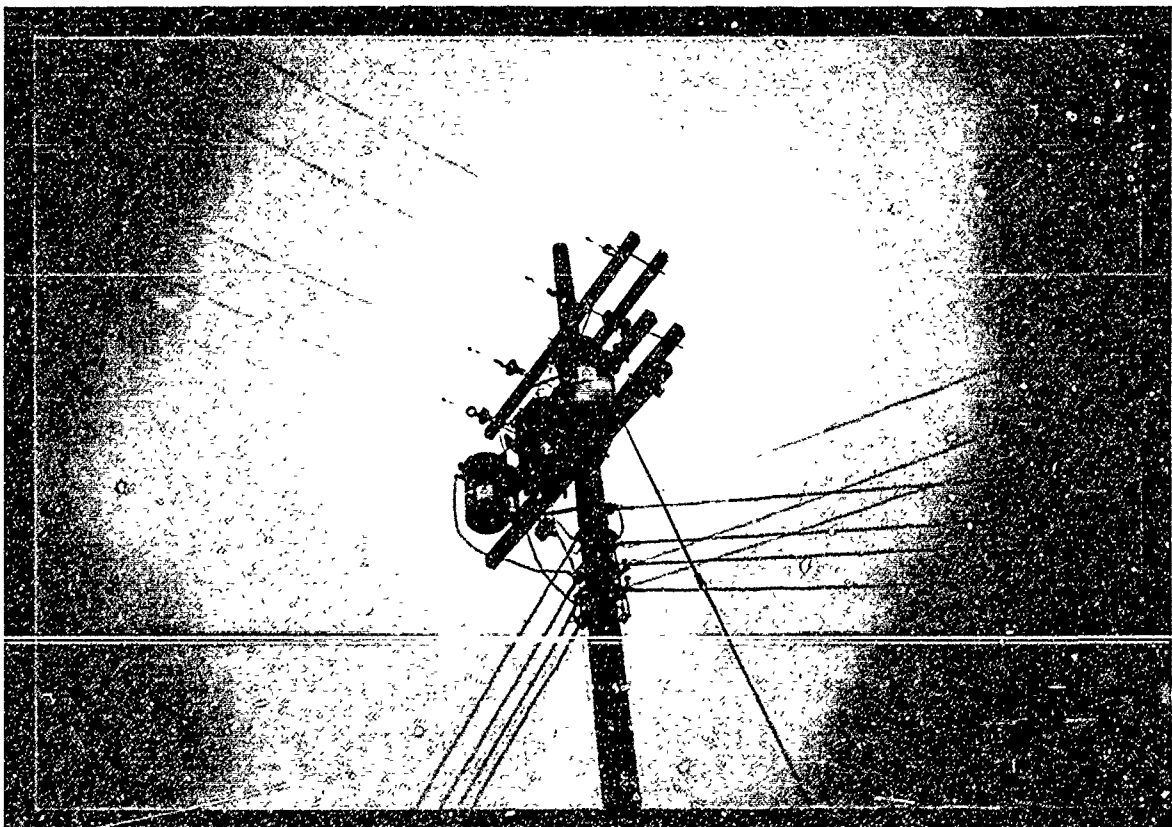
Pole-mounted transformers are present at 14 locations throughout the area to be assessed. At each location there are between one and three transformers of various ages. All these transformers are Army owned. A ground level inspection of these transformers was conducted. Some were rusted, while others appeared to be in good condition (photos 14 and 15). Figure 3-1 shows the locations of the transformers.

During the site visit, no staining was observed in the immediate area of any of the 14 transformer locations. In addition, there is no documented evidence of any past releases from these pole-mounted transformers, although there is a possibility of past releases from the rusted transformers.

14. PCB-LABELLED TRANSFORMERS

ESOs	Concern	Recommended Activity	Estimated Number and Type of Samples	Analysis
Asbestos	Inhalation	Remove or encapsulate known exposed friable asbestos. Comprehensive asbestos sampling throughout site. Ambient air sampling inside all buildings.	75 - 100 Air Samples 100 - 300 Solid Samples	Asbestos
Radon	Inhalation	No immediate investigation. Wait for results of long-term radon detectors and take appropriate action.	NA	NA
Transformers	Contact	Sample transformer fluid.	30 to 40 Oil Samples	PCBs

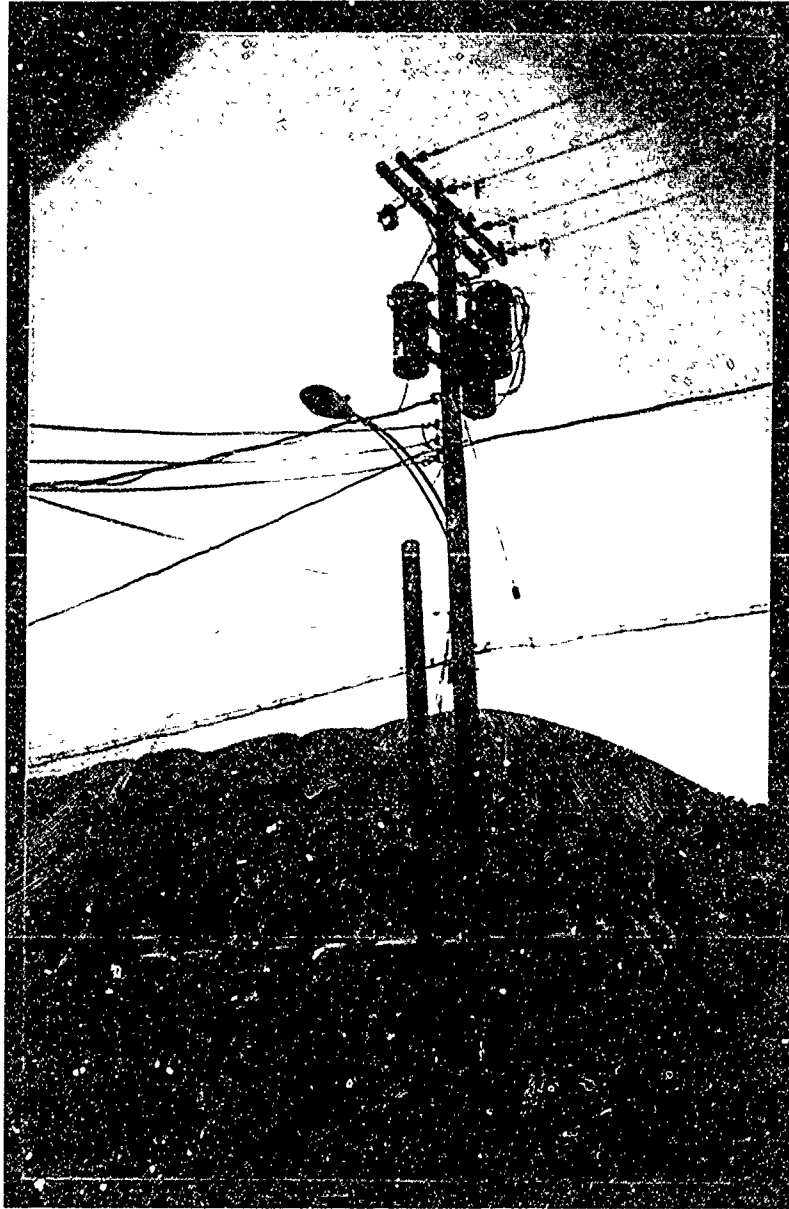
15. PCB-LABELLED TRANSFORMERS
